INTERIOR CONDITION ASSESSMENT REPORT

TUMACÁCORI NATIONAL HISTORICAL PARK

Drachman Institute | Heritage Conservation
College of Architecture, Planning, and Landscape Architecture
The University of Arizona

In conjunction with:
Tumacácori National Historical Park
DRAFT September 2014

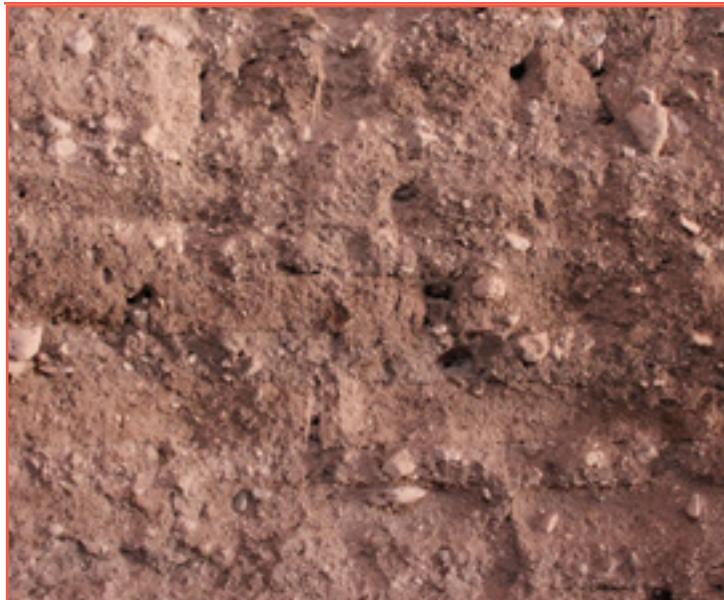
DISINTEGRATION

Areas where adobe surface has deteriorated and exhibits active granular breakdown (surface loss occurs when touched).

Often observed in conjunction with discoloration and a general deformation of adobe brick (outline of individual bricks obscured due to breakdown).

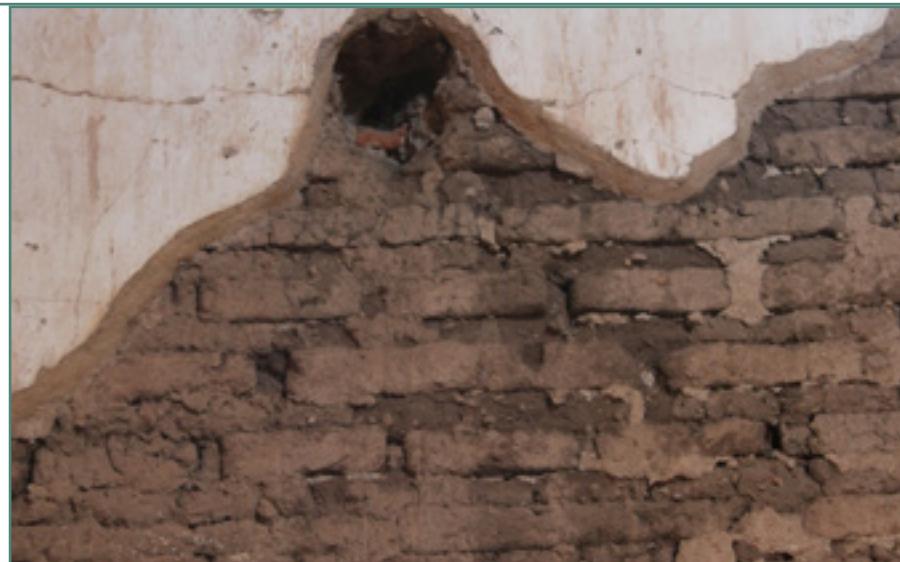
STRUCTURAL CRACK

Structural crack that penetrates the adobe substrate.

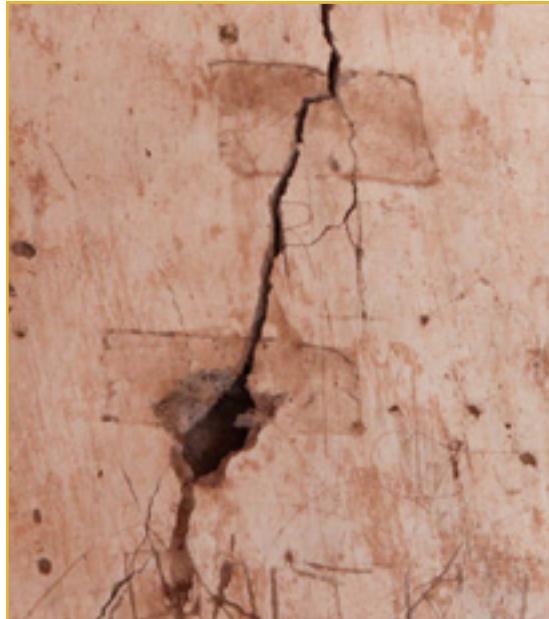
VOID

Areas in which plaster has visibly bulged or pulled away from substrate creating a gap between the plaster and the adobe, often found in conjunction with significant cracking or holes. Voids were identified by knocking when possible, or when a visible bulge in the plaster was present.

Asterisks within polygons denote areas of concern.

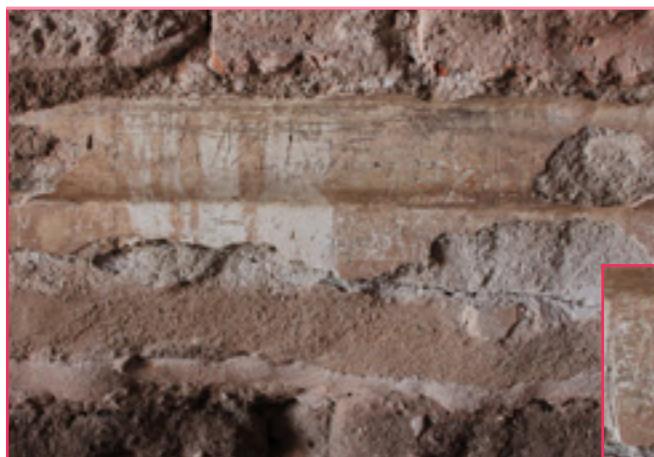
DELAMINATION

Areas in which visible detachment has occurred between adjacent layers of plaster.

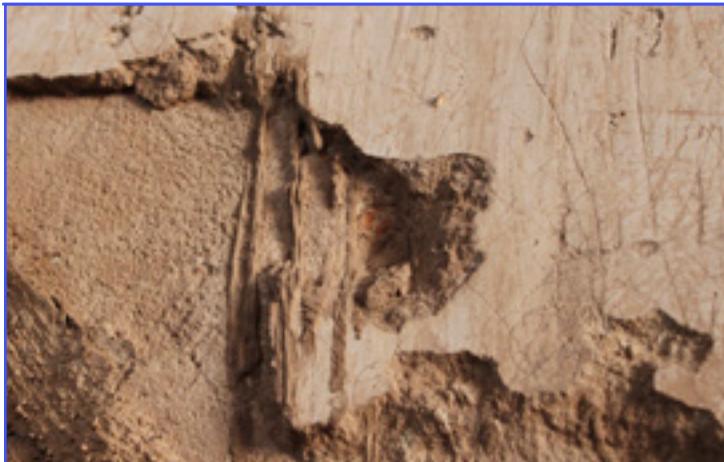
**RUNNELING**

Muddy surface deposits or channels along adobe caused by rivulets of water.

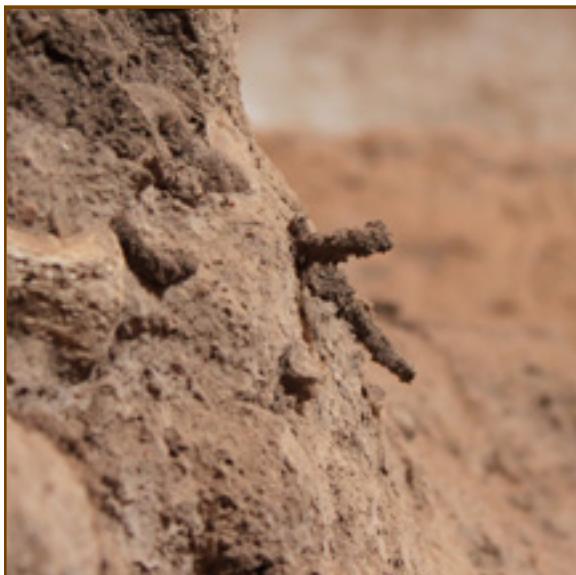
**TERMITE ACTIVITY**

Areas of visible surface deposits indicative of termite activity within the adobe.
