INTERIOR CONDITION ASSESSMENT REPORT

TUMACÁCORI NATIONAL HISTORICAL PARK

Drachman Institute | Heritage Conservation
College of Architecture, Planning, and Landscape Architecture
The University of Arizona

In conjunction with:
Tumacácori National Historical Park
DRAFT September 2014

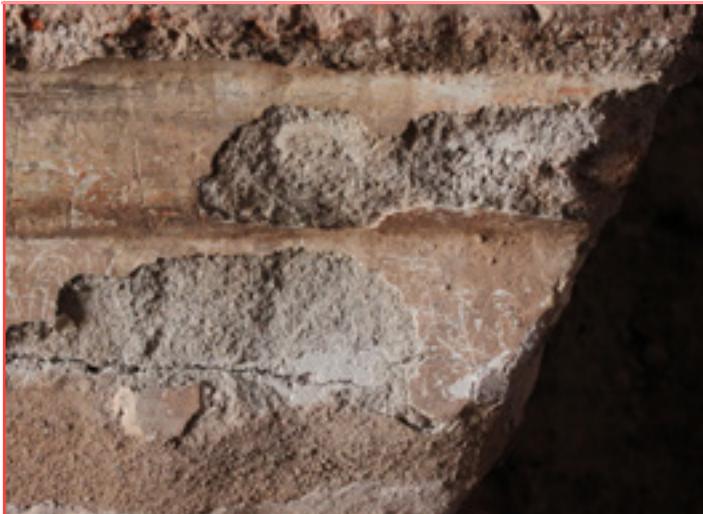
Loss of top layer of plaster on column on west side of the nave.

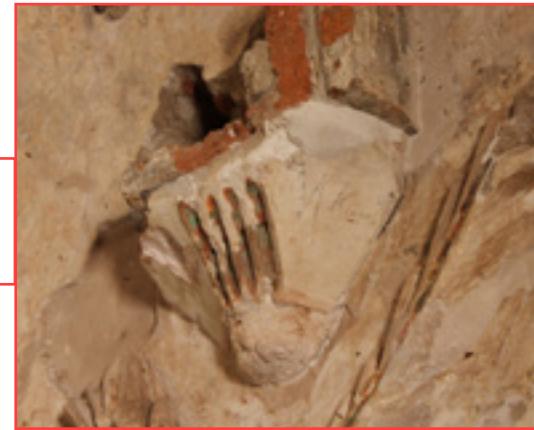
Loss of historic features in the sanctuary.

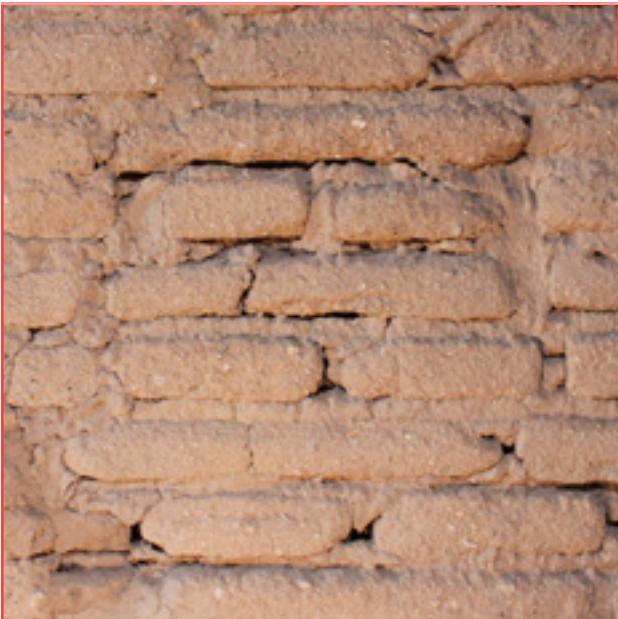
ADOBE

Denotes loss to adobe layers.

Loss occurring in mortar joints between adobe bricks.

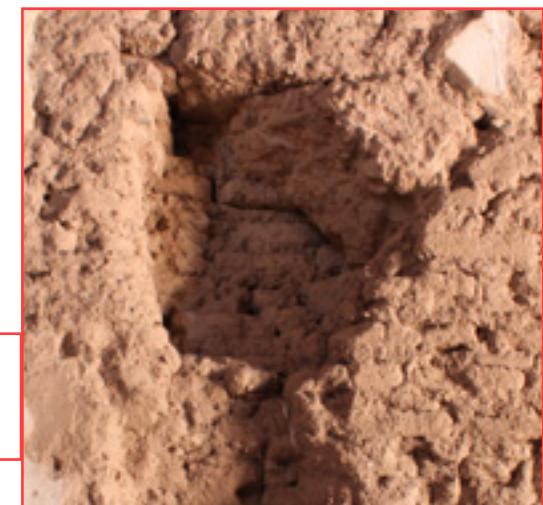
Larger scale loss of entire segments of adobe bricks.

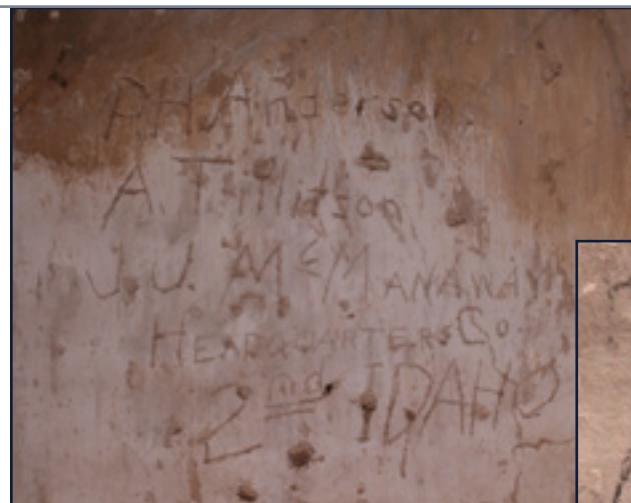
HISTORIC GRAFFITI

Areas containing historic graffiti (etched or drawn in charcoal) keyed to corresponding photograph of detail.

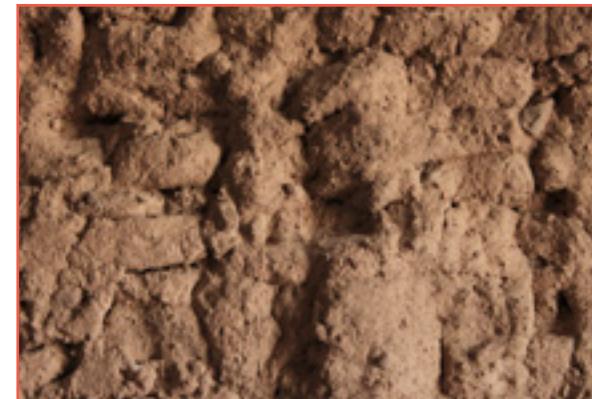
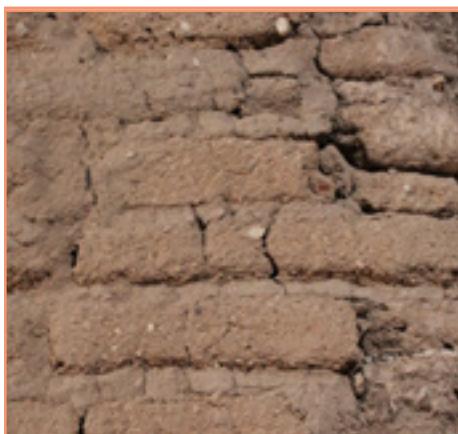
Areas where adobe surface has deteriorated and exhibits active granular breakdown (surface loss occurs when touched).

Often observed in conjunction with discoloration and a general deformation of adobe brick (outline of individual bricks obscured due to breakdown).

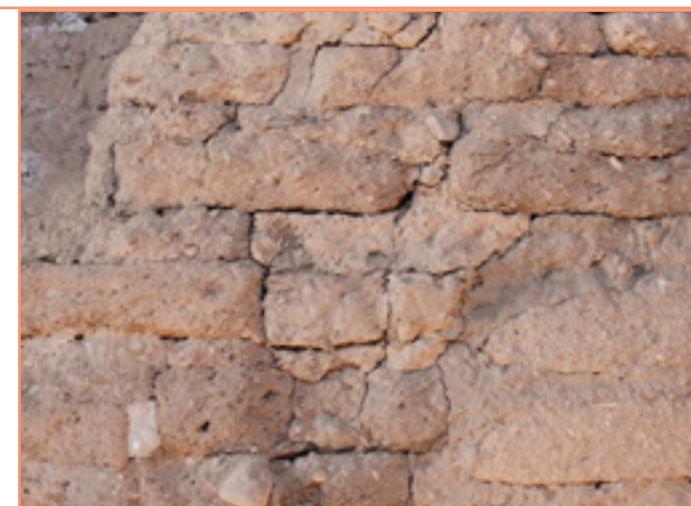
FRAGMENTATION

Areas where individual adobe bricks exhibit visible structural cracks due to stress or pressure.

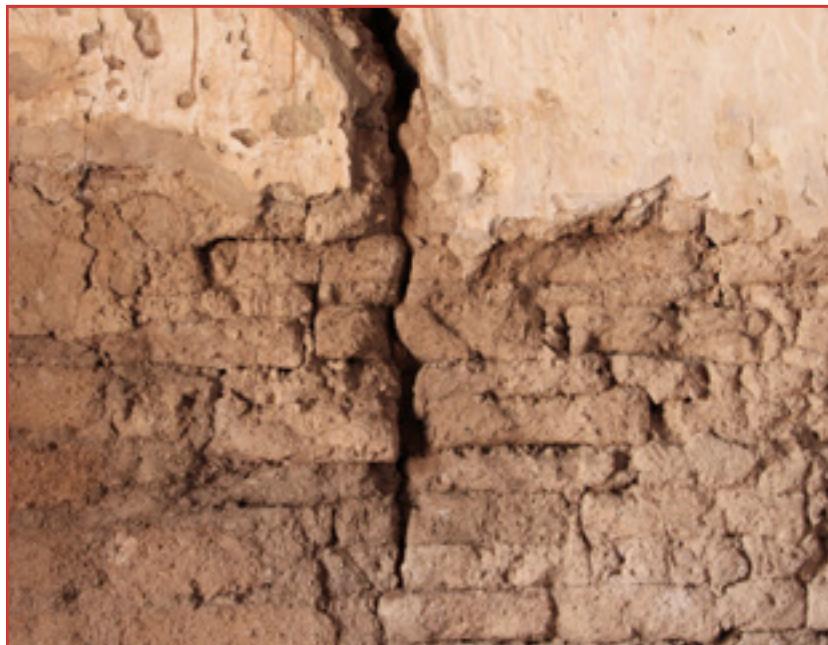
STRUCTURAL CRACK

Structural crack that penetrates the adobe substrate.

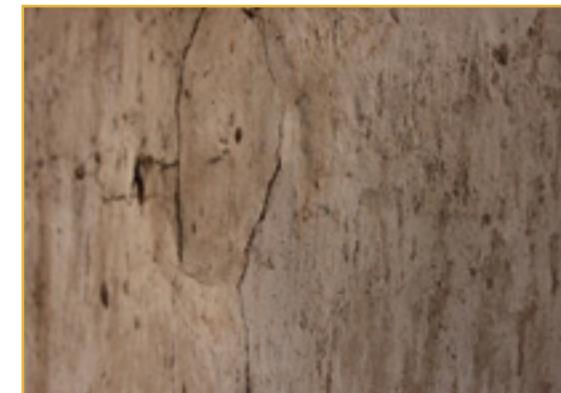
Areas in which plaster has visibly bulged or pulled away from substrate creating a gap between the plaster and the adobe, often found in conjunction with significant cracking or holes. Voids were identified by knocking when possible, or when a visible bulge in the plaster was present.

Asterisks within polygons denote areas of concern.

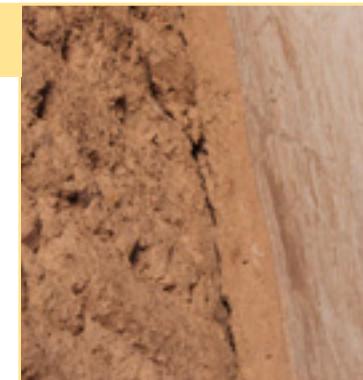
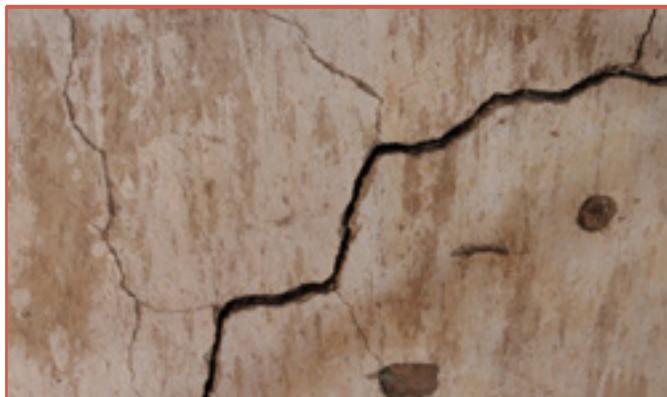
**DETACHMENT**

Areas in which plaster has visibly detached from adobe substrate.

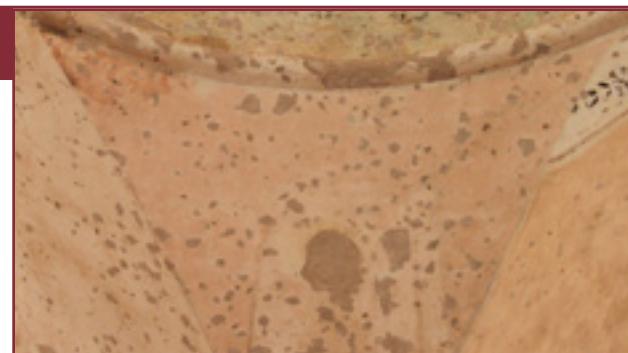
PITTING

Areas of concentrated loss in top layer of plaster caused by "lime pops." Recorded only in upper corners of Sanctuary.

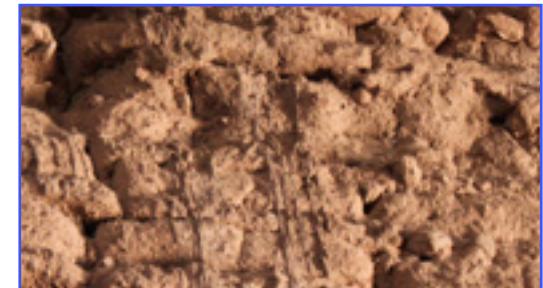
**RUNNELING**

Muddy surface deposits or channels along adobe caused by rivulets of water.

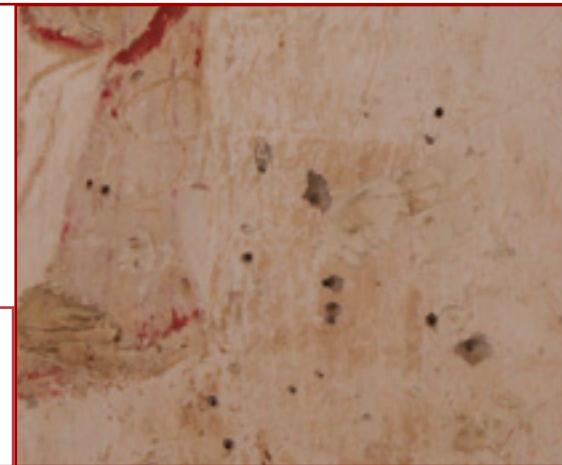
SMALL HOLES

Holes created by insect or small animal activity in both adobe and plaster surfaces.

Small, deep holes observed in lower half of plastered portion of sanctuary walls.

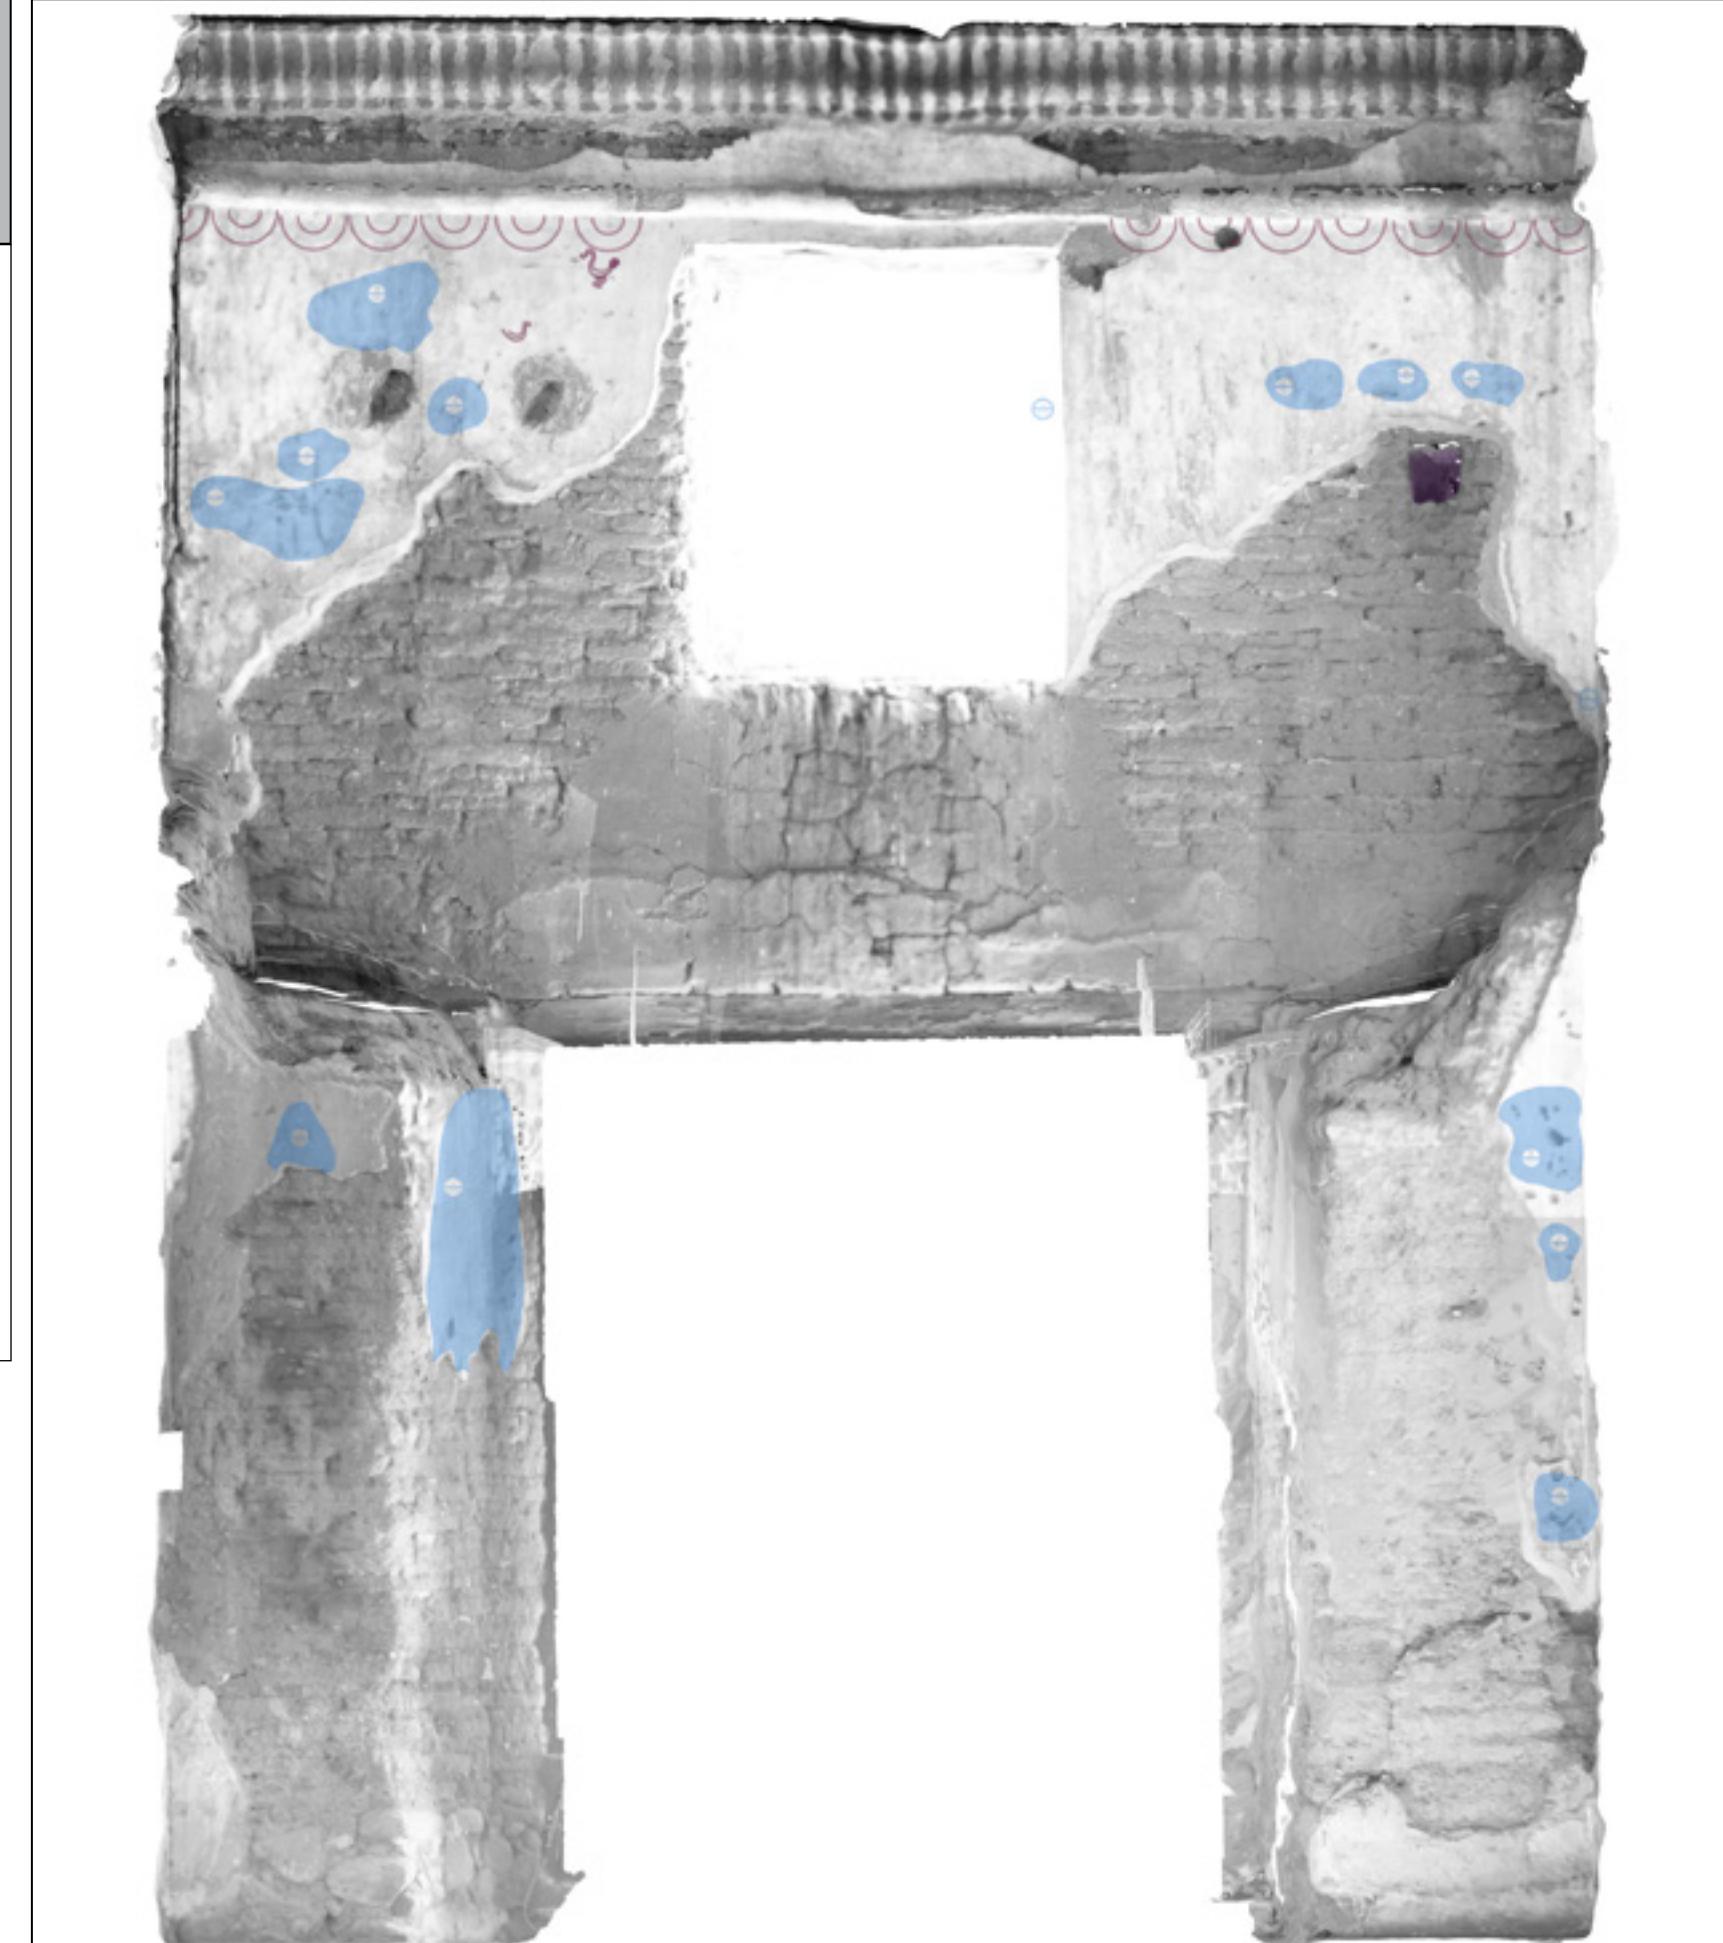
TUMACACORI MISSION CHURCH: CHOIR LOFT: CONDITIONS

- DISINTEGRATION
- FRAGMENTATION
- DISCOLORATION
- STRUCTURAL CRACK

- VOID
- DELAMINATION
- DETACHMENT
- SURFICIAL CRACK

- RUNNELING
- DROPPINGS
- SMALL HOLES

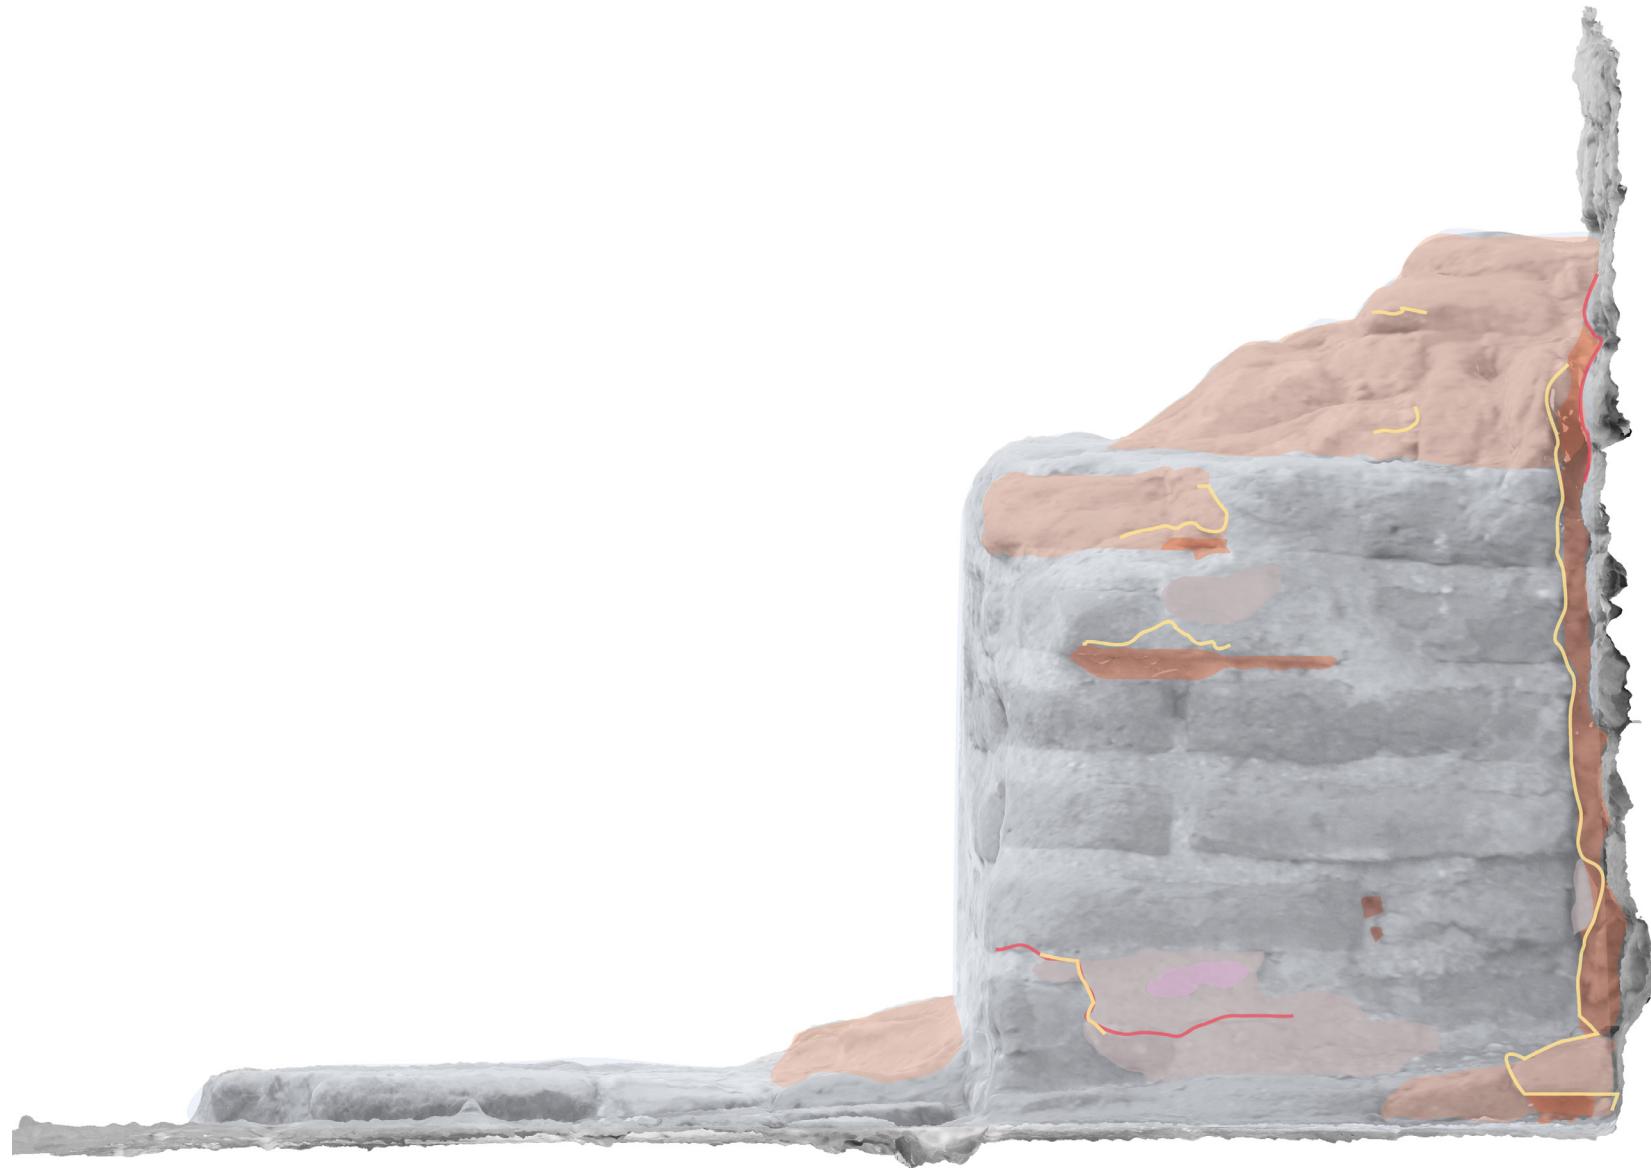
WEST WALL, NAVE

FRAGMENTATION
DETACHMENT
DELAMINATION
ANIMAL HOLES

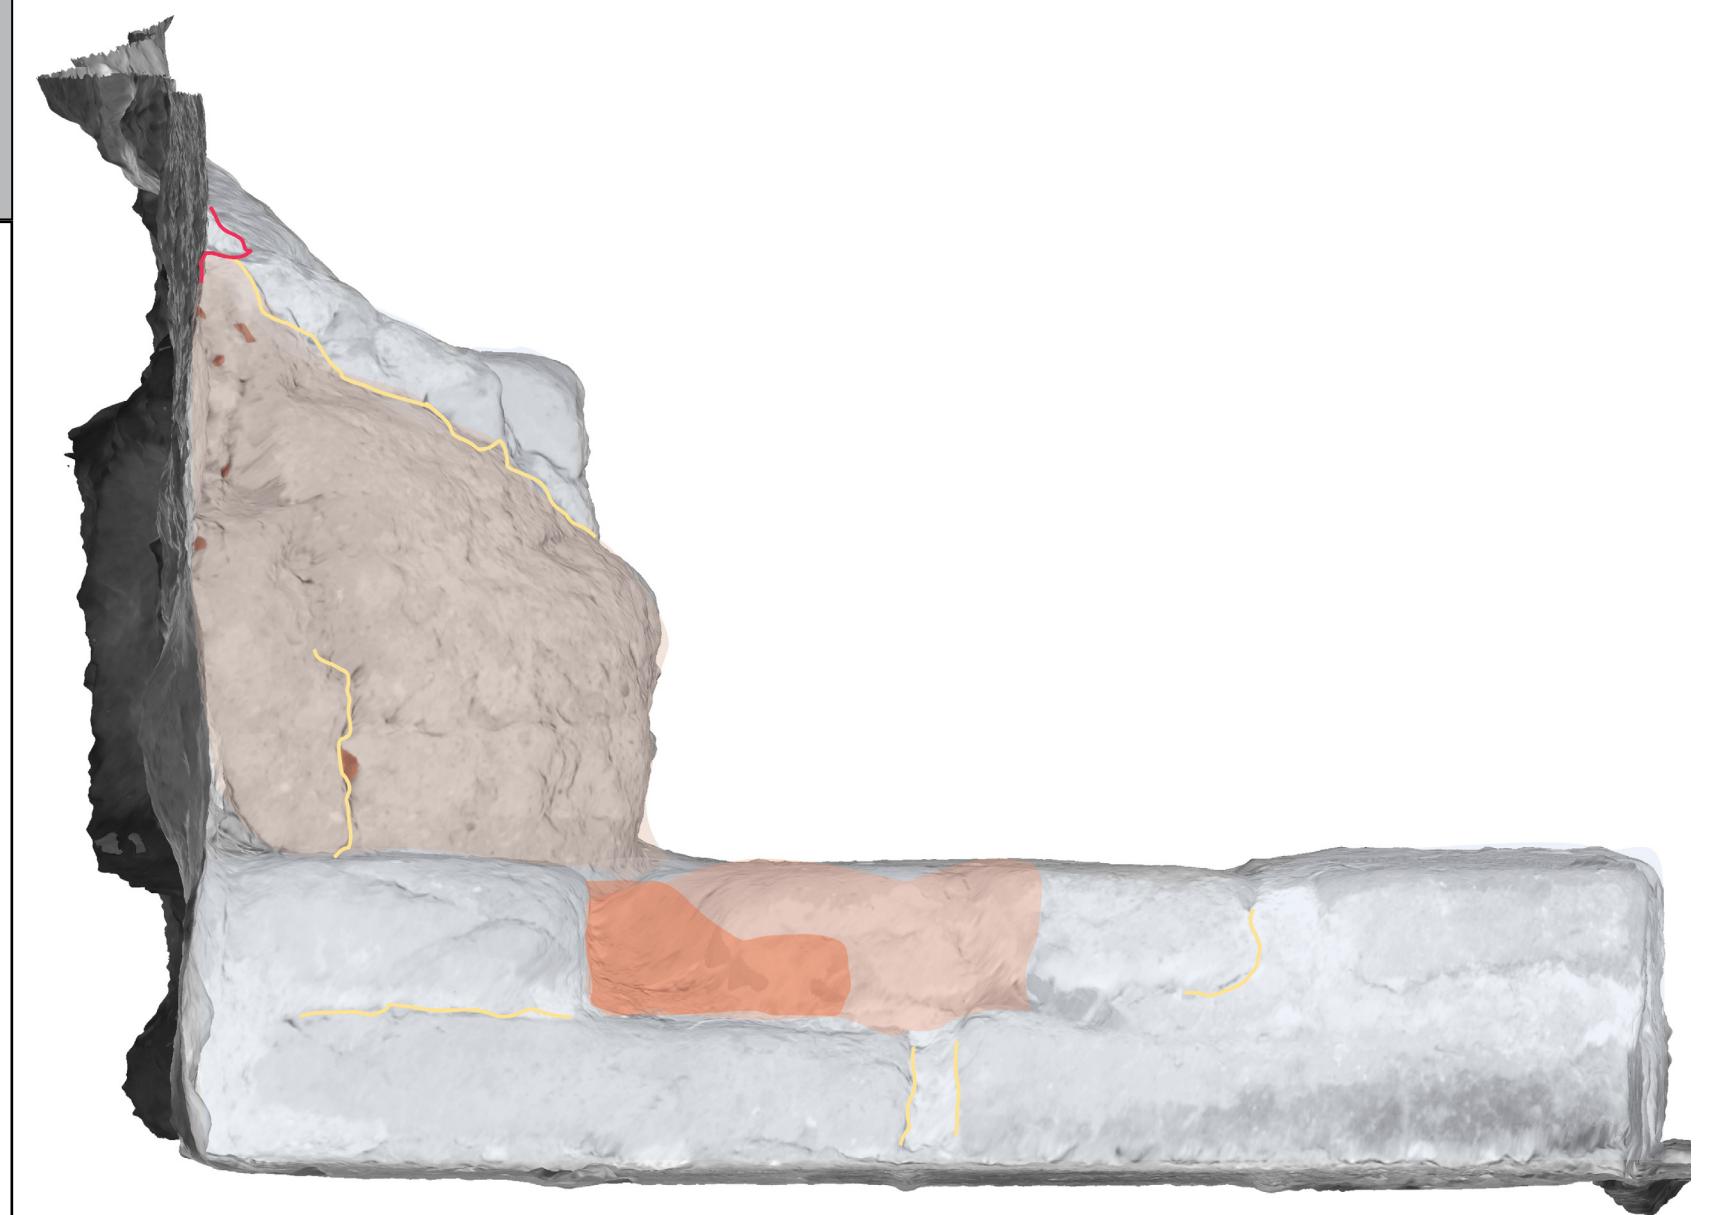
WEST WALL, NAVE

- FRAGMENTATION
- DETACHMENT
- DELAMINATION
- ANIMAL HOLES

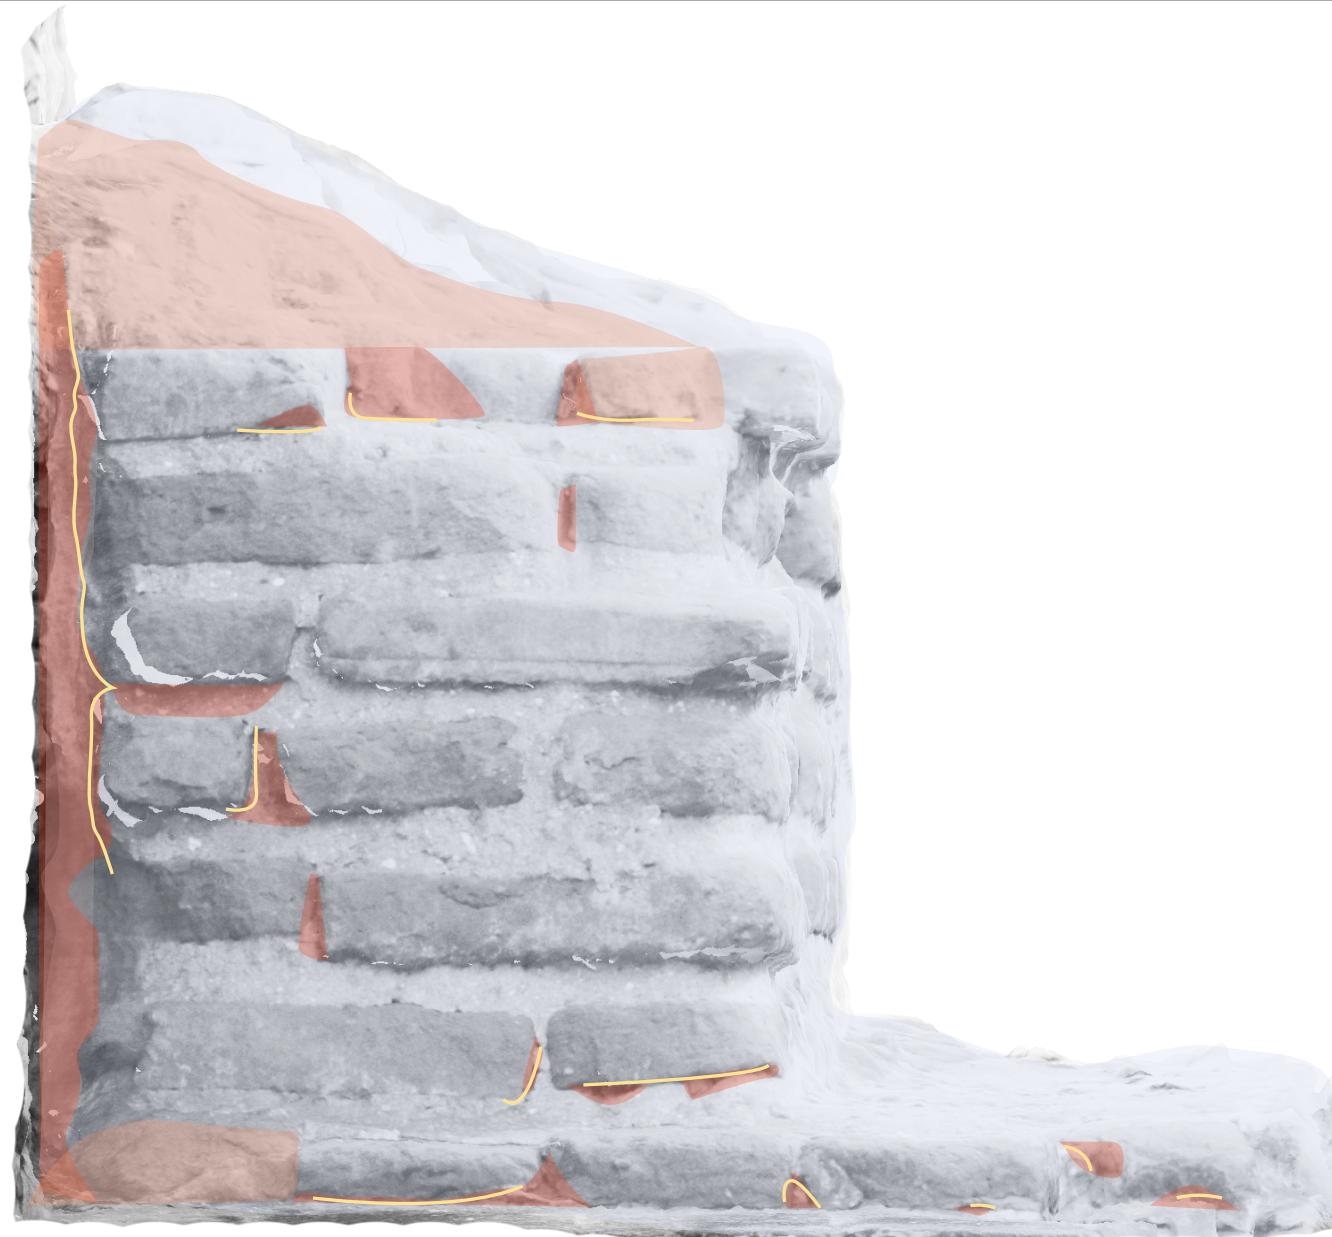
TUMACACORI MISSION CHURCH
SIDE ALTARS
EAST WALL, ALTAR ONE, PLAN VIEW

- FRAGMENTATION
- DETACHMENT

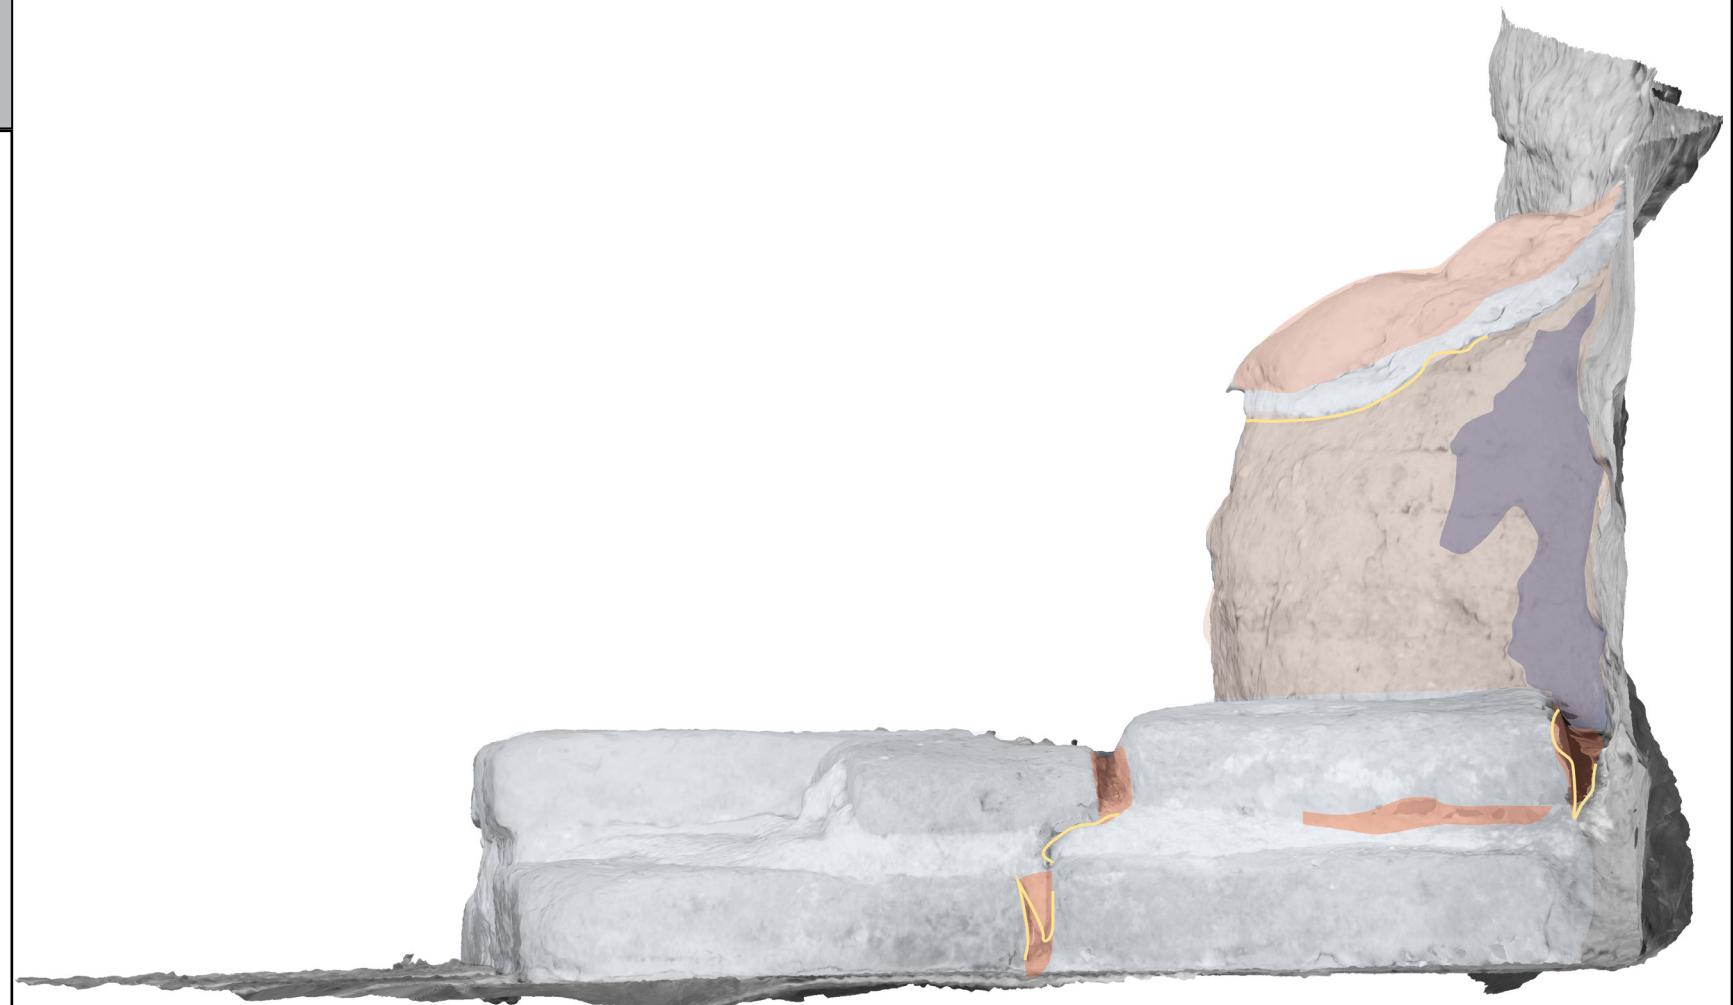
EAST WALL, NAVE

- FRAGMENTATION
- DETACHMENT

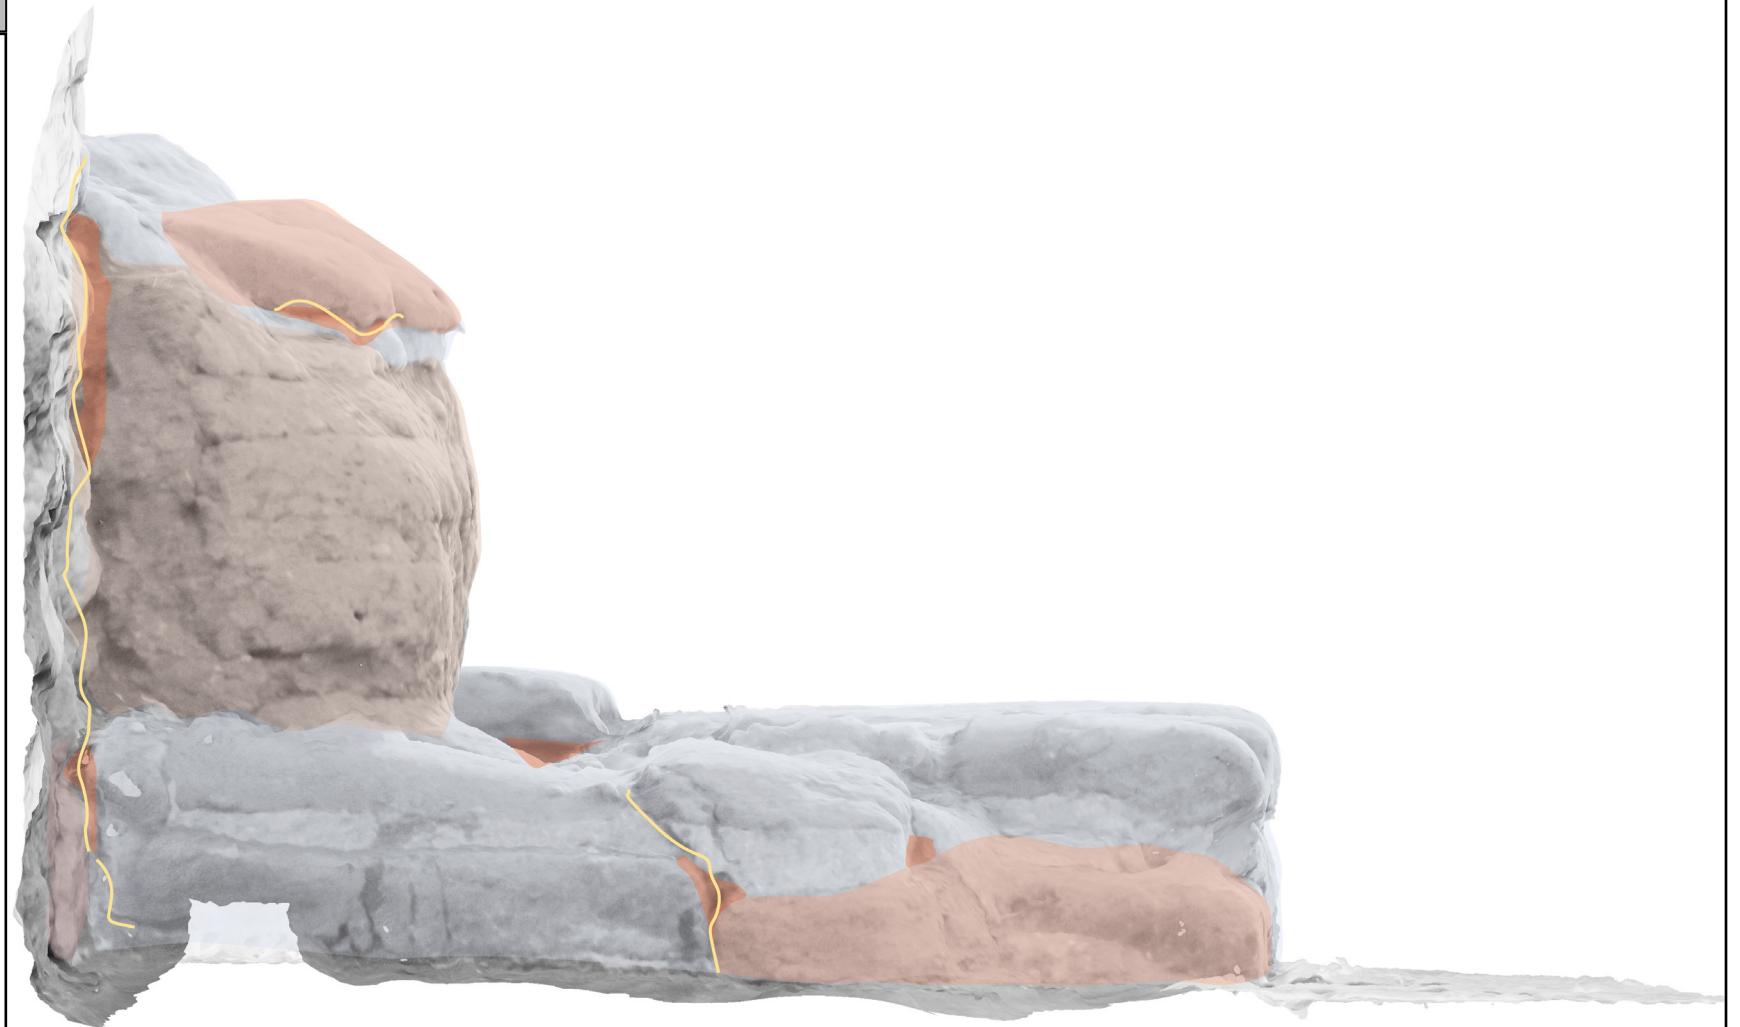
EAST WALL, NAVE

- FRAGMENTATION
- DETACHMENT

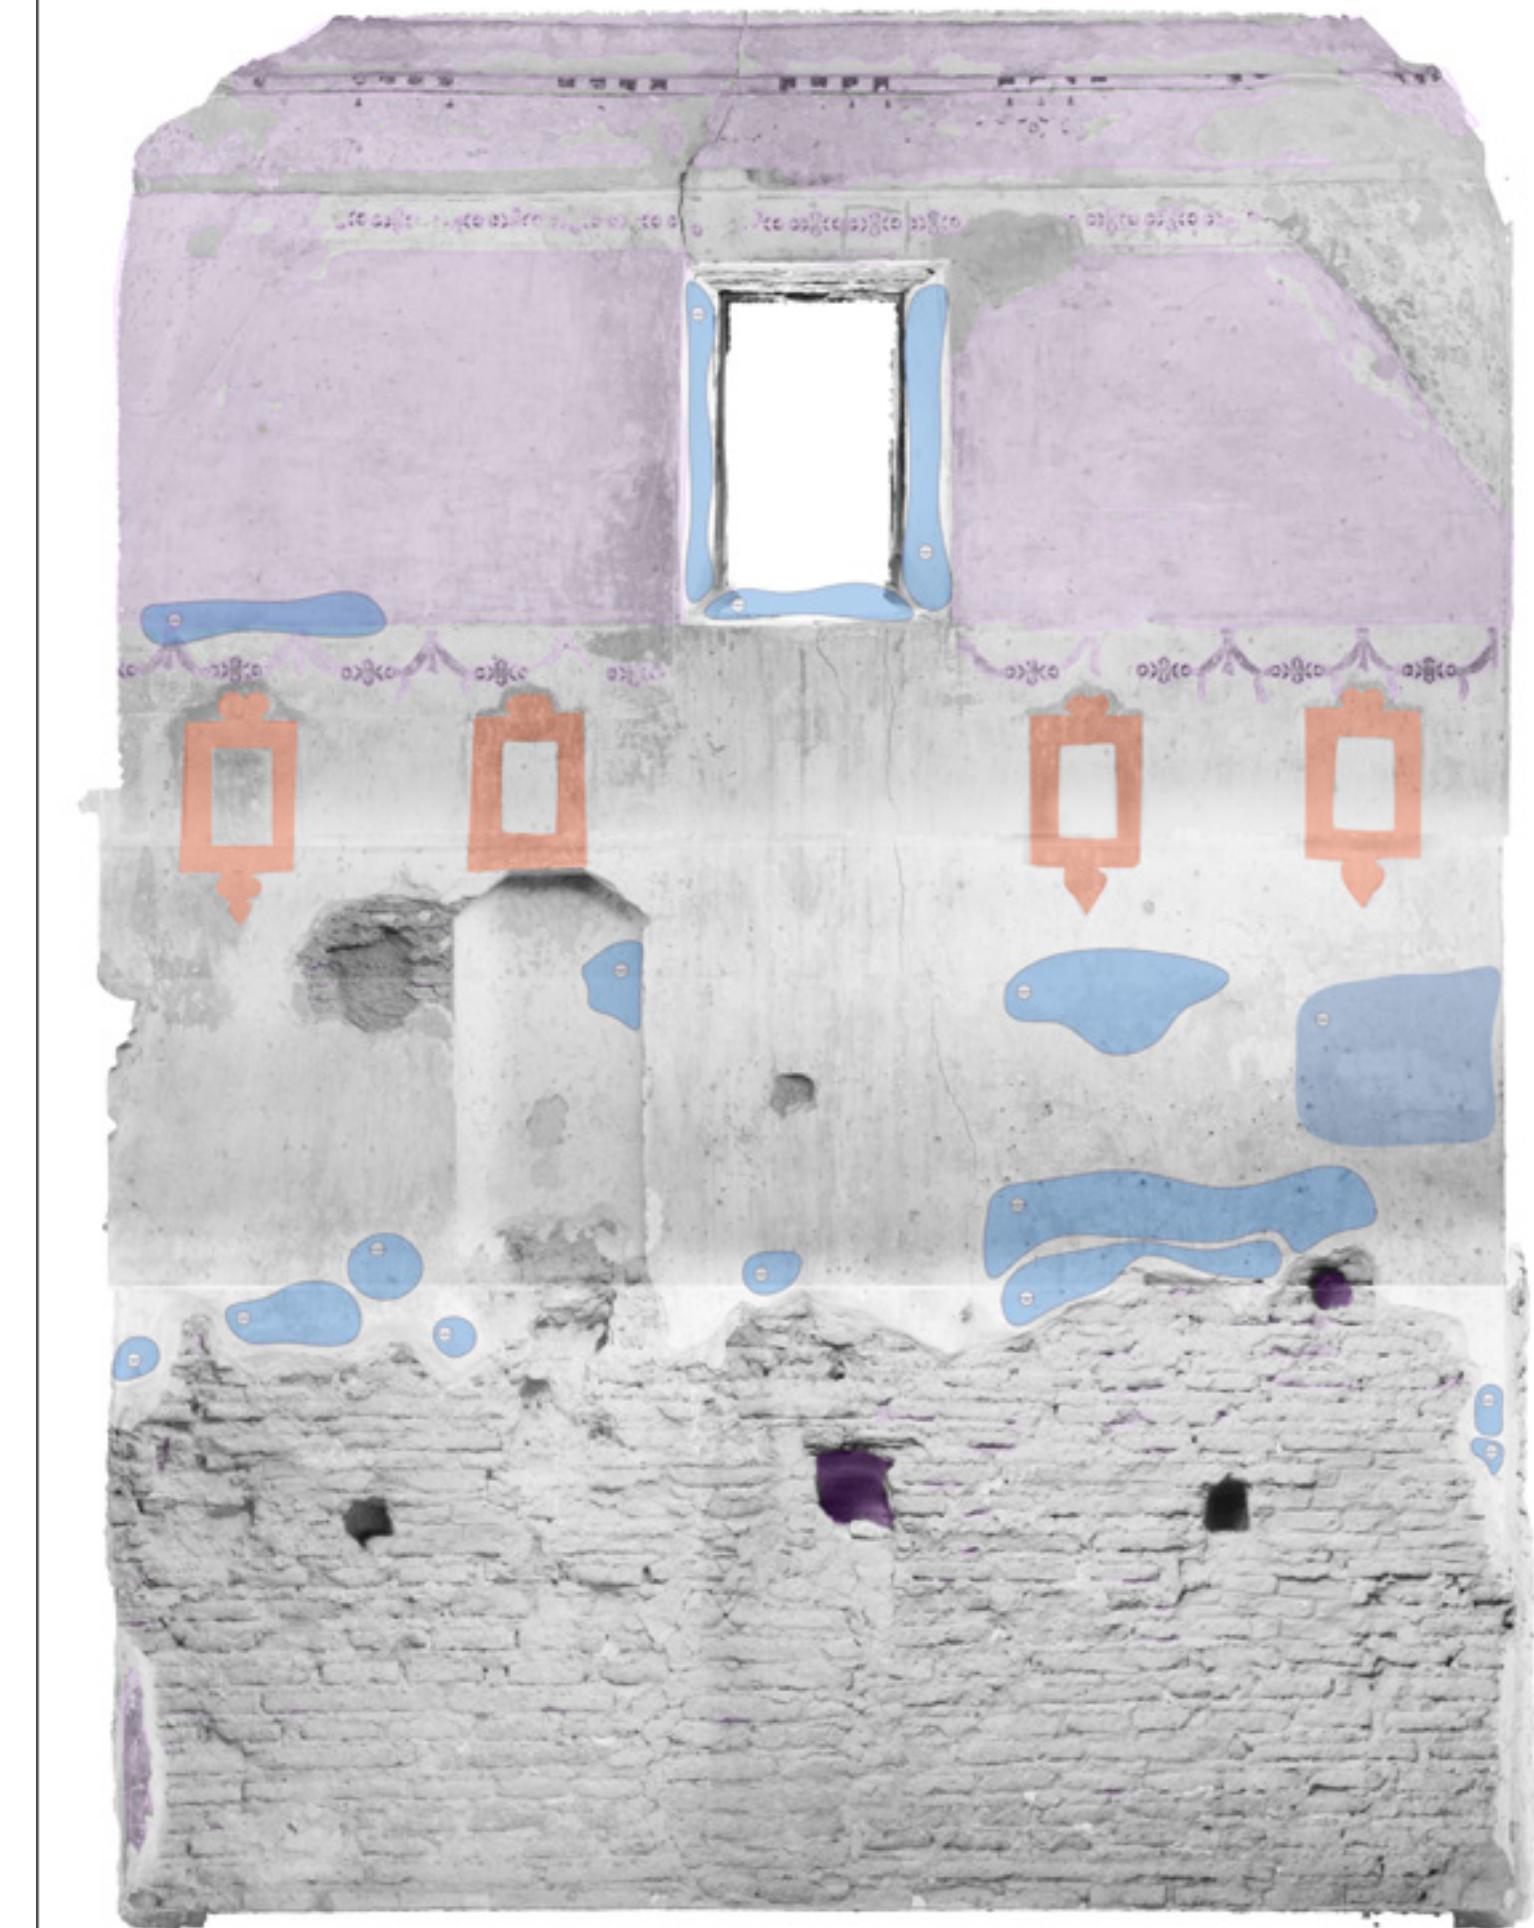
TUMACACORI MISSION CHURCH SANCTUARY, WEST WALL: CONDITIONS

- DISINTEGRATION
- FRAGMENTATION
- DISCOLORATION
- STRUCTURAL CRACK

- VOID
- DELAMINATION
- DETACHMENT
- SURFICIAL CRACK

- RUNNELING
- DROPPINGS
- SMALL HOLES
