INTERIOR CONDITION ASSESSMENT REPORT

TUMACÁCORI NATIONAL HISTORICAL PARK

Drachman Institute | Heritage Conservation
College of Architecture, Planning, and Landscape Architecture
The University of Arizona

In conjunction with:
Tumacácori National Historical Park
DRAFT September 2014

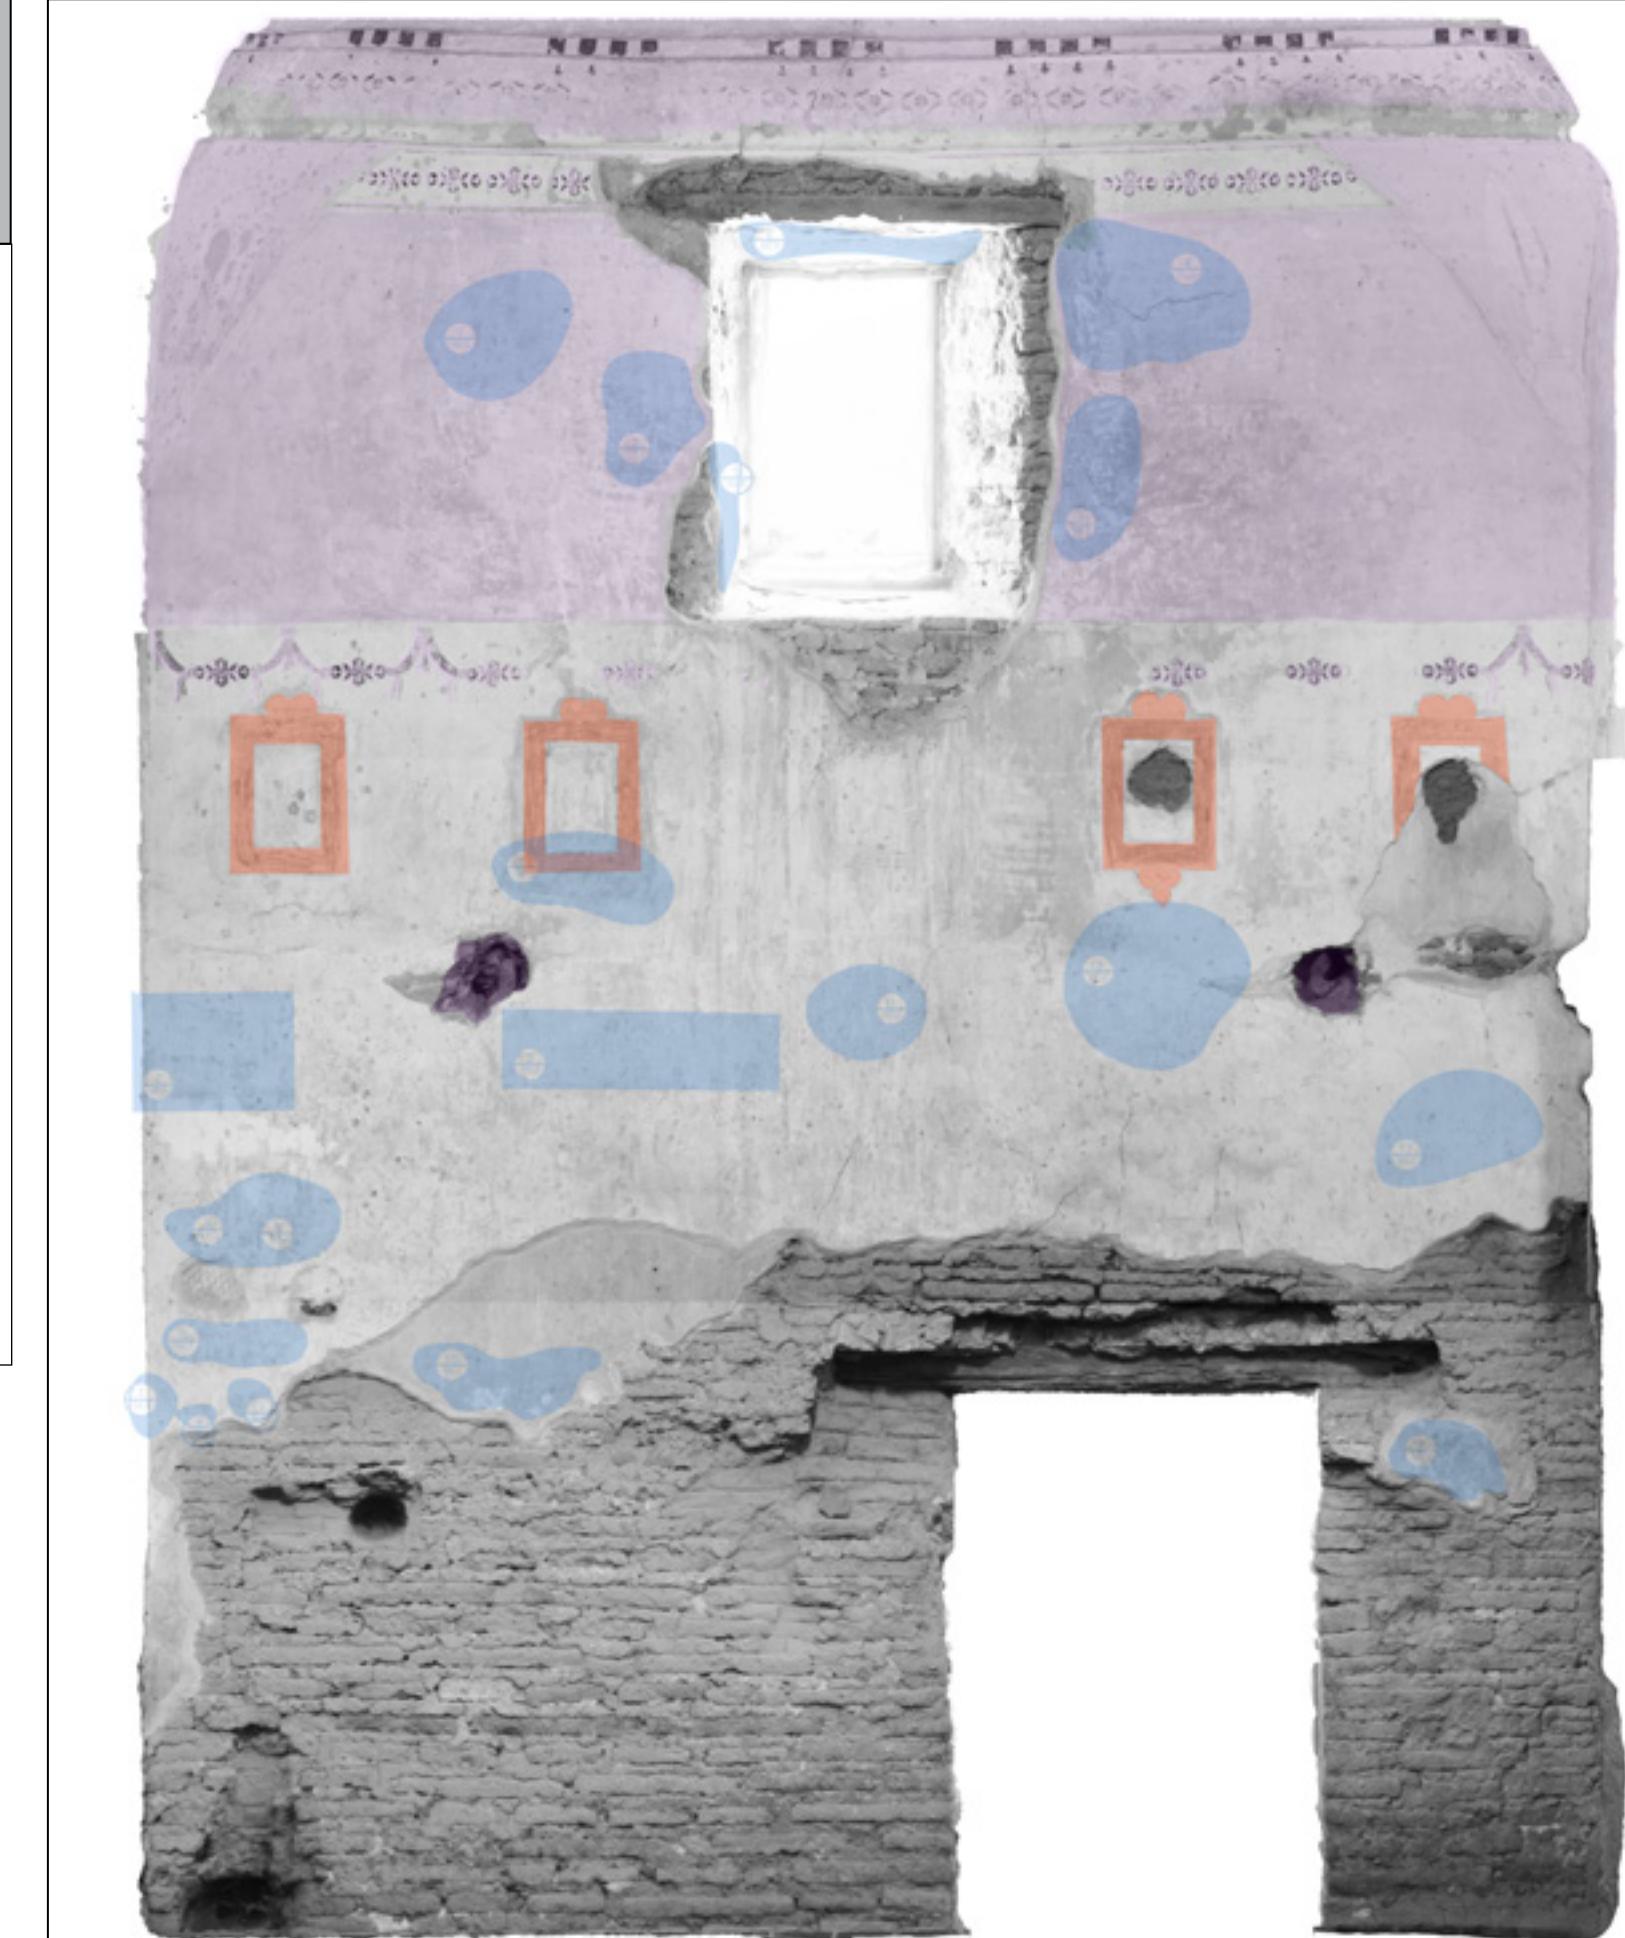
TUMACACORI MISSION CHURCH SANCTUARY, EAST WALL: CONDITIONS

- DISINTEGRATION
- FRAGMENTATION
- DISCOLORATION
- STRUCTURAL CRACK

- VOID
- DELAMINATION
- DETACHMENT
- SURFICIAL CRACK

- RUNNELING
- DROPPINGS
- SMALL HOLES

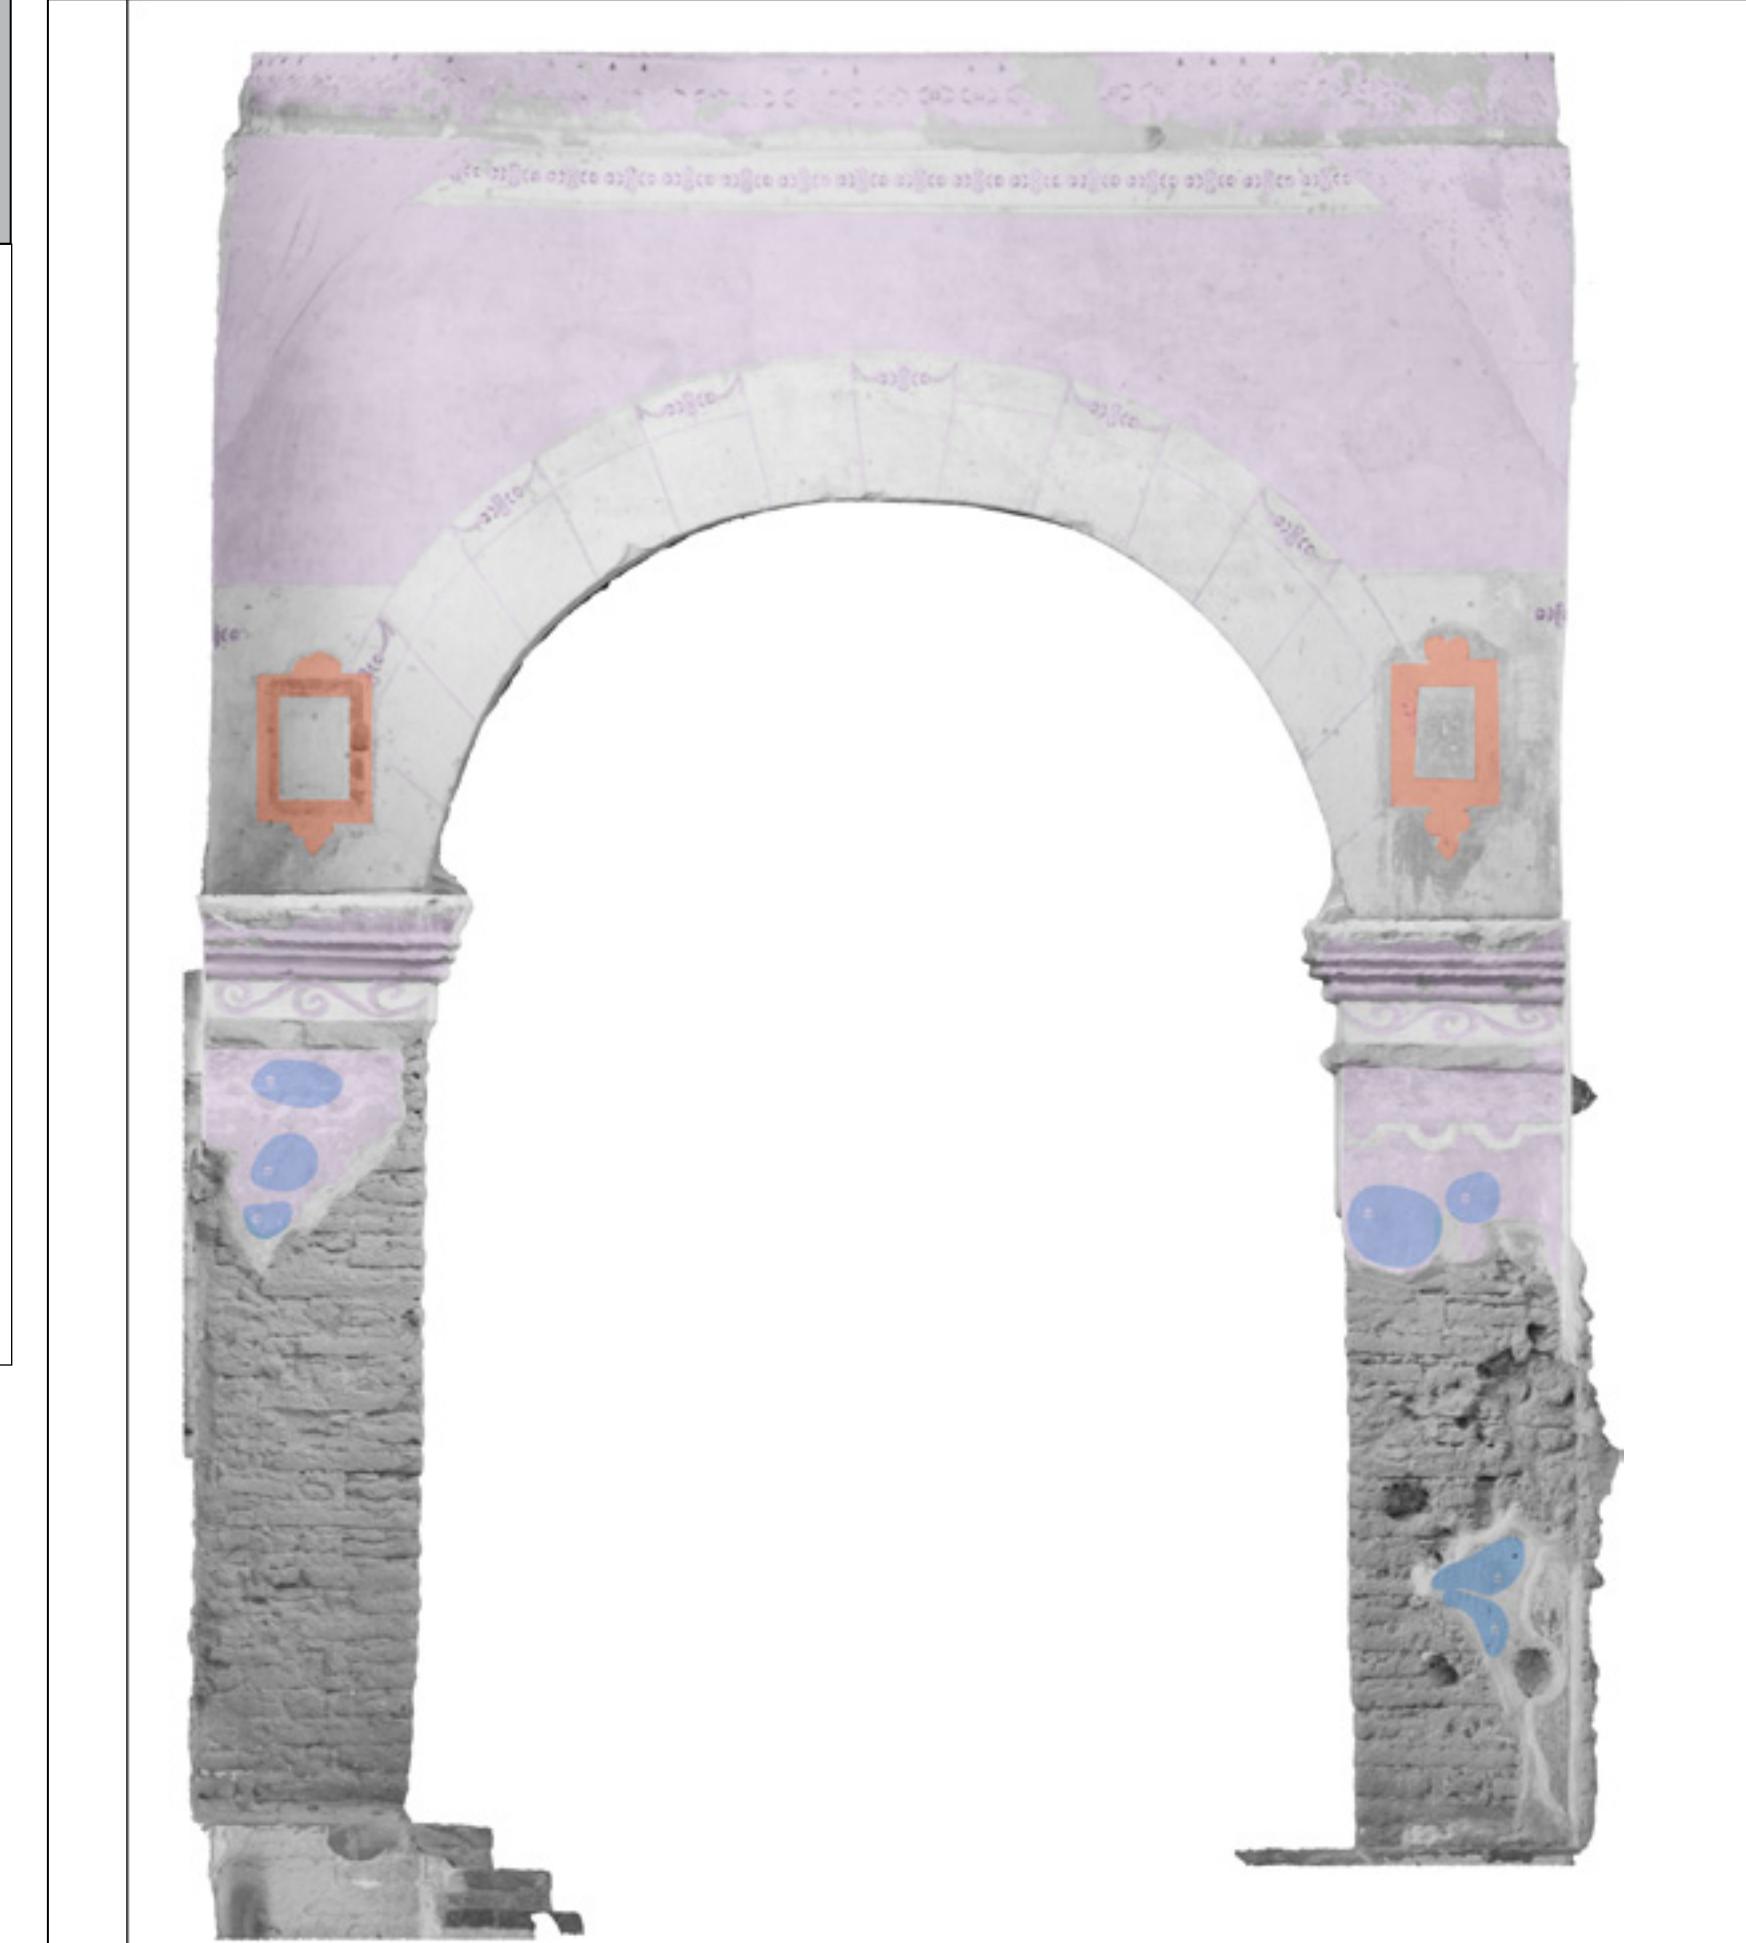
TUMACACORI MISSION CHURCH SANCTUARY, SOUTH WALL: CONDITIONS

- DISINTEGRATION
- FRAGMENTATION
- DISCOLORATION
- STRUCTURAL CRACK

- VOID
- DELAMINATION
- DETACHMENT
- SURFICIAL CRACK

- RUNNELING
- DROPPINGS
- SMALL HOLES
